DEMONSTRATION AND VALIDATION OF THERMAL SPRAY VITRIFICATION OF LEAD-CONTAINING PAINT ON STEEL STRUCTURES

CERL TR 99/61

July 1999

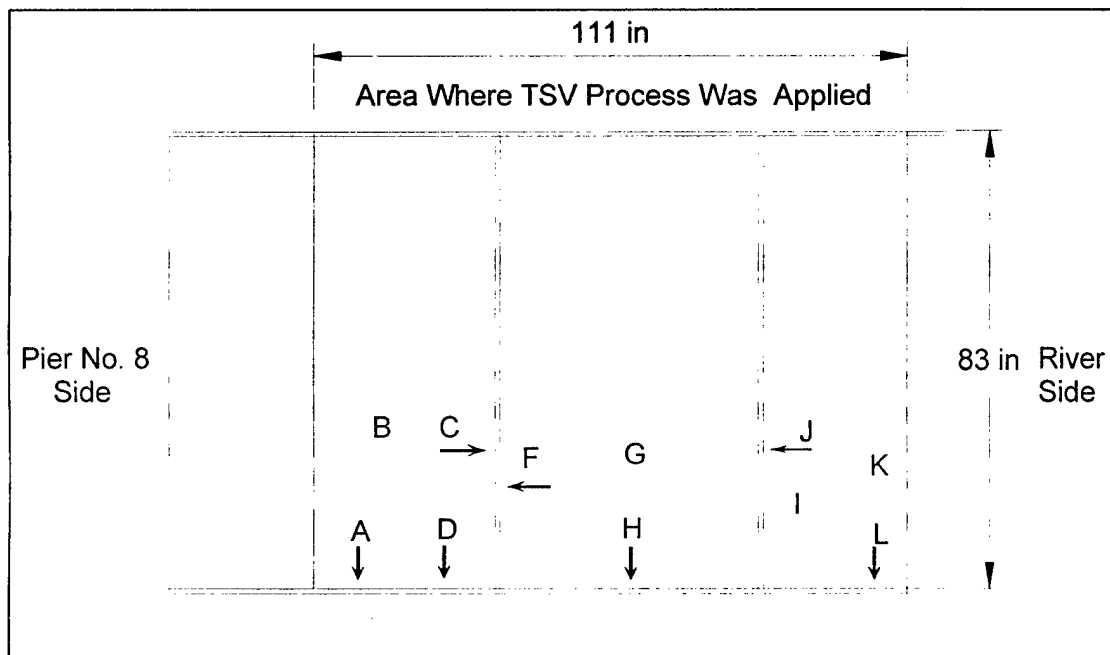
Figure C-1. Location of thickness measurements of existing paint system before application of TSV, east side.

Table C-1. Thickness of existing paint system before TSV application, east side.

Location	Measured Thickness (mils)	Measured Thickness (mils)	Measured Thickness (mils)	Average Thickness
A	11.8	10.4	9.5	10.6
B	4.7	4.3	4.4	4.5
C	6.7	7.1	7.3	7.0
D	5.0	5.5	6.3	5.6
E	3.5	3.2	3.1	3.3
F	2.3	2.2	2.6	2.4
G	5.5	6.7	5.4	5.9
H	18.1	19.6	15.7	17.8
I	7.1	6.0	6.4	6.5
j	6.3	8.3	7.6	7.4
K	9.8	9.0	7.6	8.8

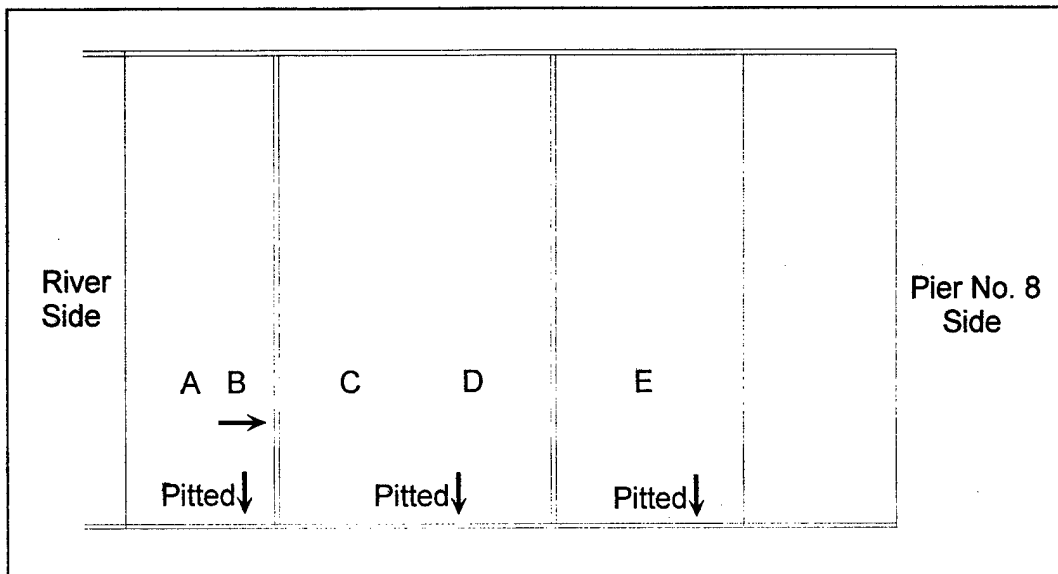
Figure C-2. Location of thickness measurements of existing paint system before application of TSV, west side.

Table C-2. Thickness of existing paint system before TSV application (west side).

Location	Measured Thickness (mils)	Measured Thickness (mils)	Measured Thickness (mils)	Average Thickness
A	3.4	3.1	3.5	3.3
B	7.2	6.4	4.6	6.1
C	4.3	4.4	4.1	4.2
D	3.5	3.1	3.2	3.3
E	3.1	3.3	3.5	3.3

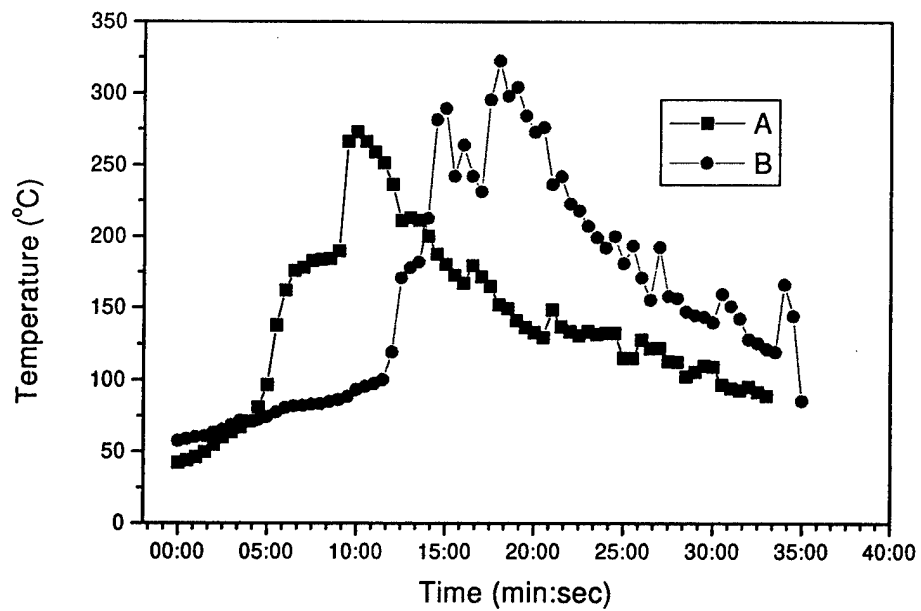
During the initial application of TSV, it was noted by the operator that the vertical web of the beam was warping. The application of TSV was immediately stopped and the degree of warping was measured and found to range up to 3/8 inch. A structural engineer from the Corps of Engineers Rock Island District inspected the beam and concluded that the warping did not adversely impact the structural integrity of the beam or of the bridge. The warping was due to excess heat applied to the vertical web of the beam during preheating of the substrate. The steel temperature on the back of a vertical web of the bridge was measured with a thermal couple during application of the TSV to the front side of the vertical web and is shown in Figure C-3 and C-4. The maximum temperature recorded for the two locations was 273 °C (523 °F) and 322 °C (611 °F).

Figure C- 4. Steel temperature measurements during TSV application.

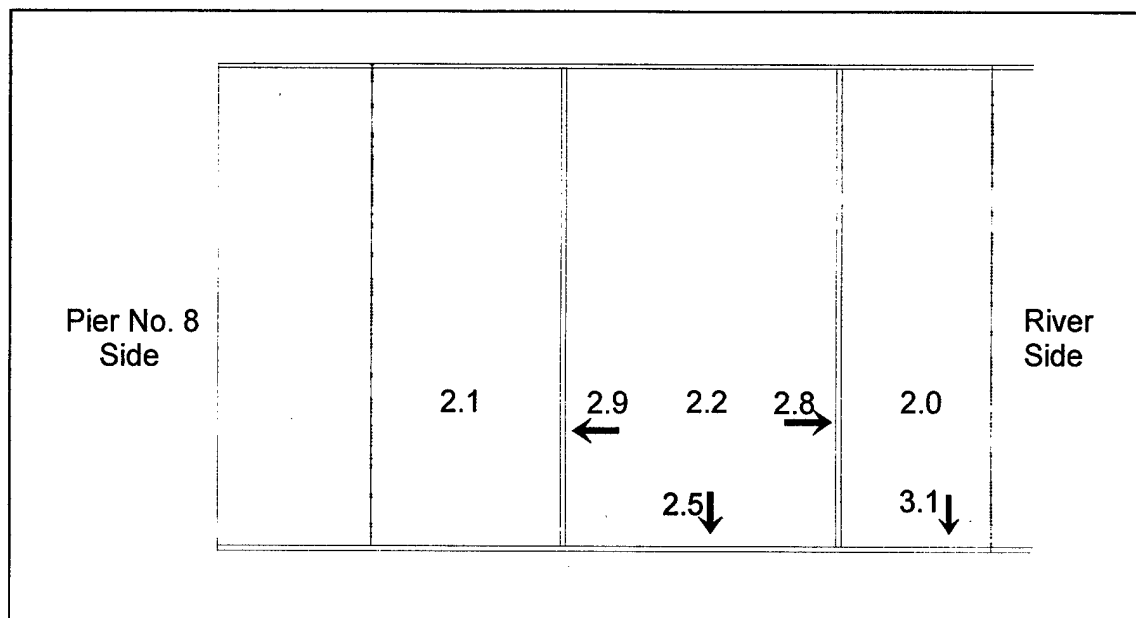
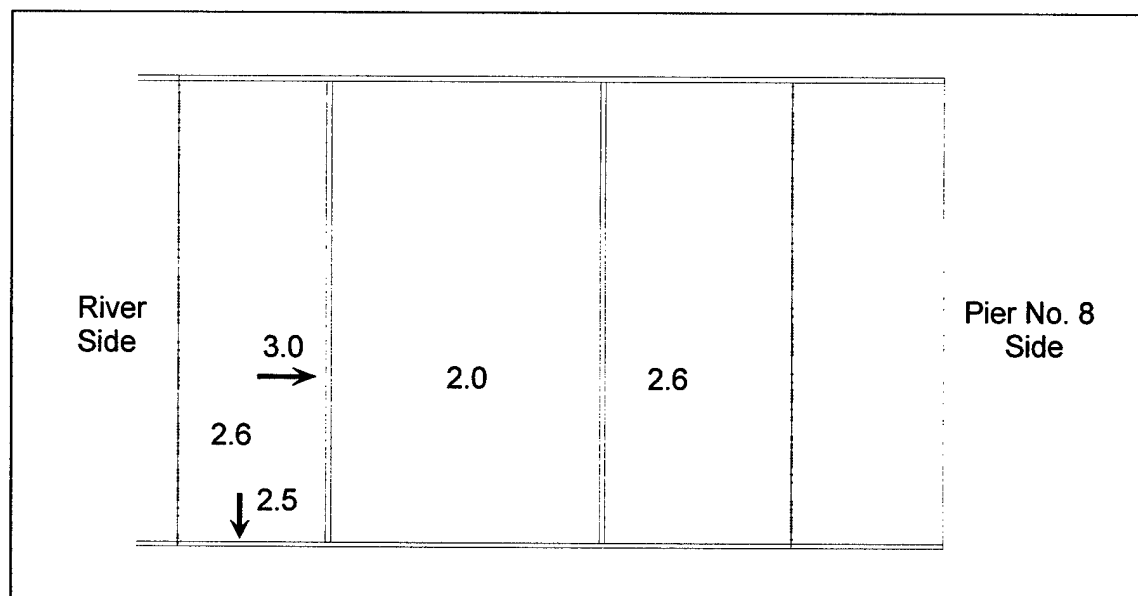
TSV met the principal performance criteria of providing surface preparation for repainting. Following application of TSV, the surface was inspected by personnel from the Paint Technology Center at U.S. Army Construction Engineering Research Laboratory and was found to meet the requirements of the Steel Structures Painting Council (SSPC) SP1 and SP3 required in the contract specification and was suitable for repainting with a surface tolerant coating system. The surface profile was measured using ASTM D 4417 and found to range from 2.0 to 3.0 mils, Figures C-5 and C-6.

Figure C- 5. Surface profile after TSV application (mils), east side.

Figure C- 6. Surface profile after TSV application (mils), west side.

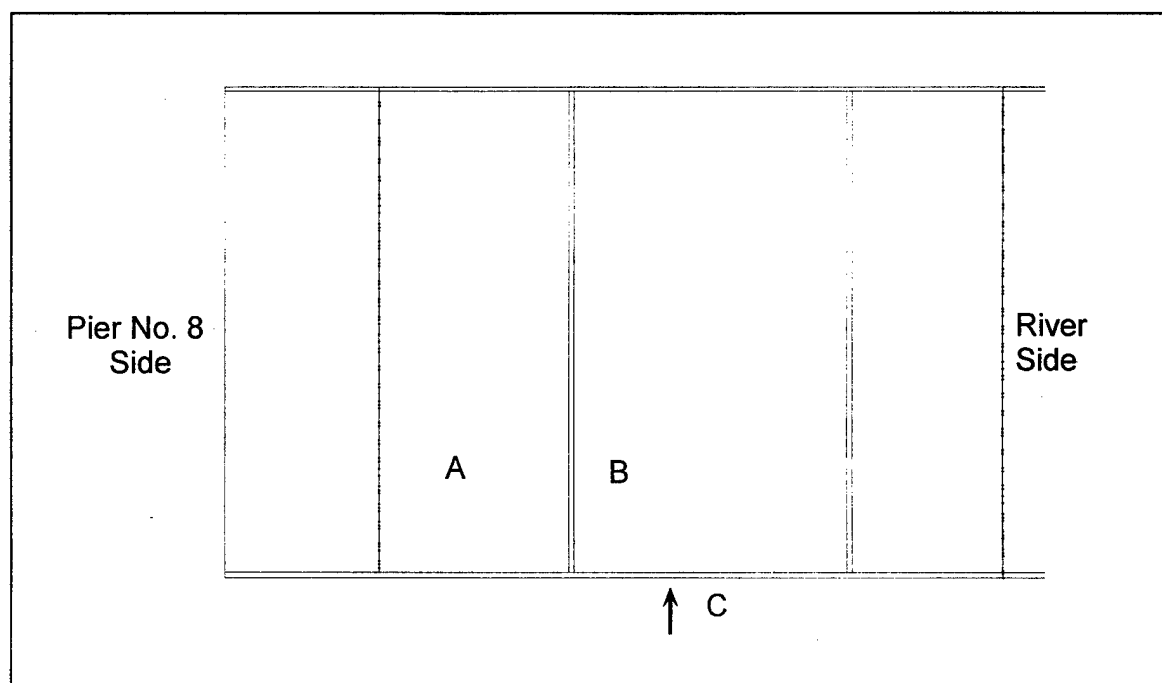
Figure C- 12. Location of lead-concentration measurements after TSV application.

Table C-8. Lead concentration using x-ray fluorescence spectroscopy after TSV application, east side.

Location	Instrument Sample No.	Lead Concentration. (mg/cm ²)
A	107.2	1.03
B	107.3	2.32
C	107.5	1.46

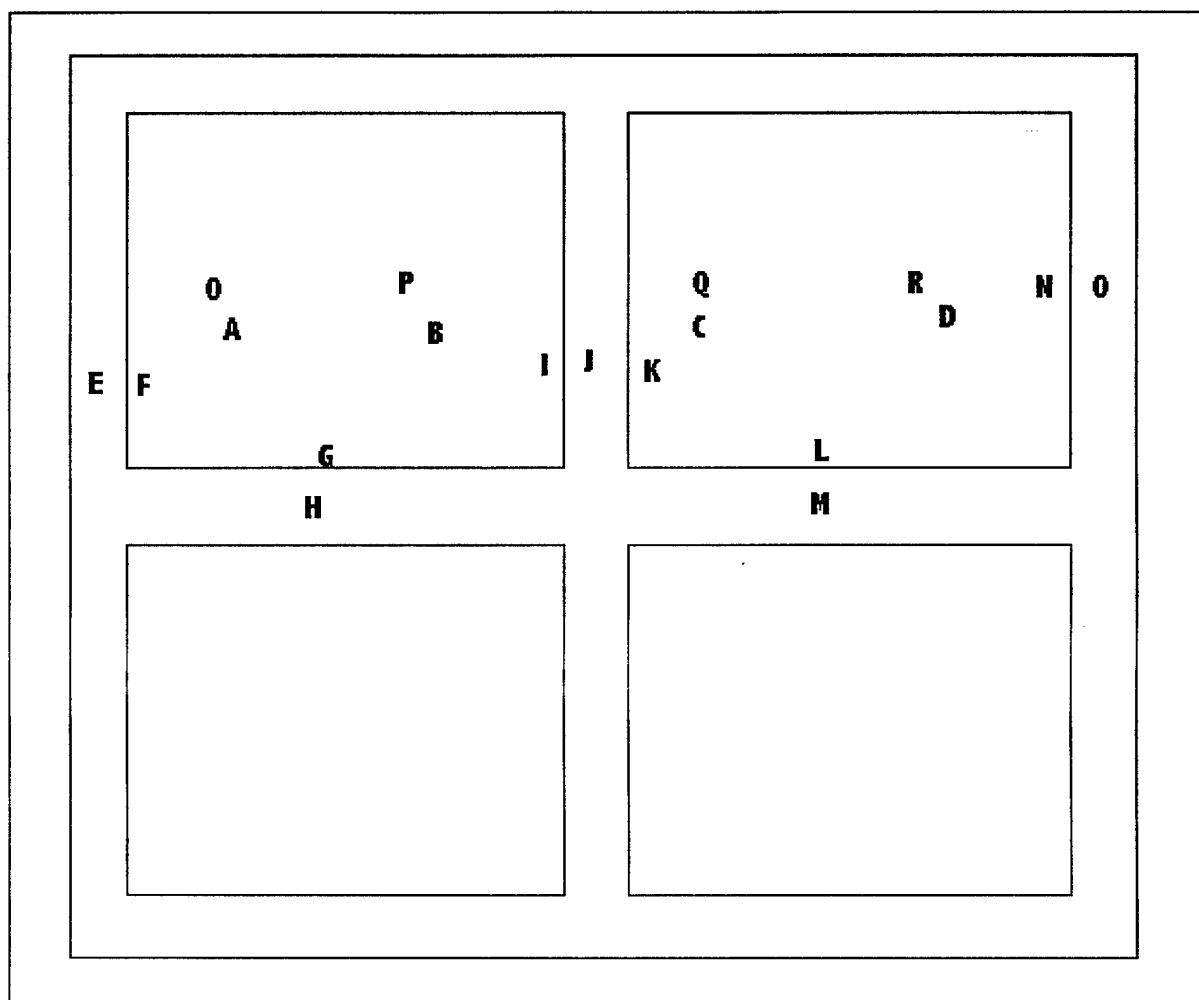
Figure D- 3. Locations of XRF measurements before TSV.

Table D-4. Lead concentration measurements before TSV.

Outside Skin	Lead, mg/cm ²	Inside Skin	Lead, mg/cm ²	Framing	Lead, mg/cm ²
A	1.72	O	4.27	E	19.95
B	2.77	P	9.07	F	12.29
C	1.43	Q	5.37	G	14.42
D	4.39	R	3.06	H	2.79
				I	16.57
				J	13.31
				K	13.76
				L	12.5
				M	9.44
				N	13.25
				O	11.5

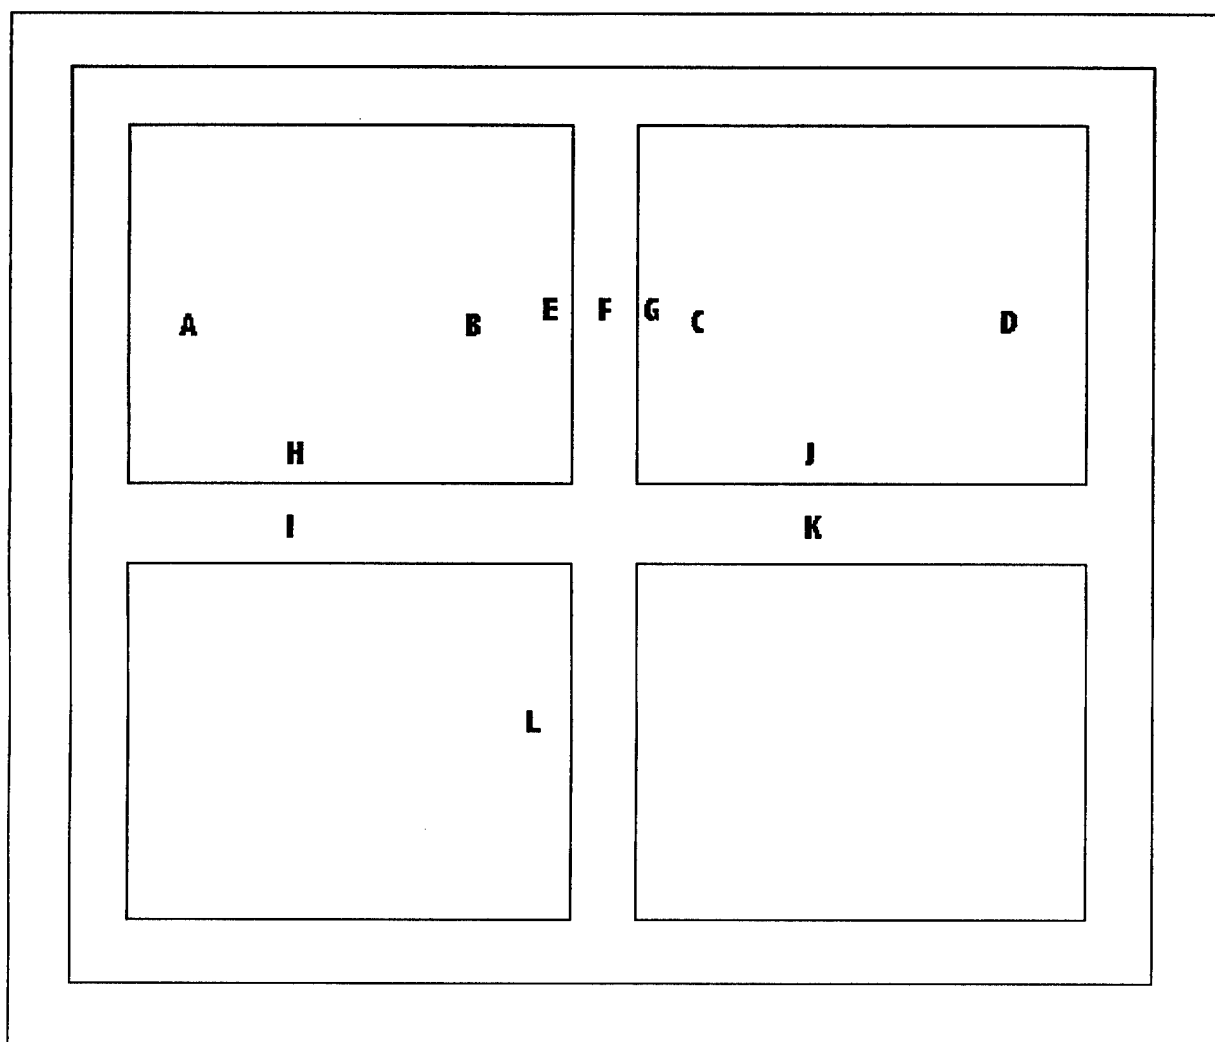
Figure D- 4. Location of XRF measurements after TSV and before needle gun cleanup.

Table D-5. Lead concentration after TSV and before needle gun cleanup.

Inside Skin	Lead, mg/cm ²	Framing	Lead, mg/cm ²
A	0.14	E	1.82
B	2.88	F	1.10
C	1.9	G	5.63
D	0.94	H	1.59
		I	2.95
		J	3.33
		K	1.29
		L	3.51
